Hybrid Hermeticity And Failure Analysis

BY GEORGE R. NEFF, ISOVAC ENGINEERING INC., GLENDALE, CALIF.

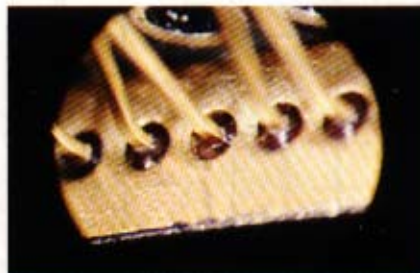
Handling: Undoubtedly the most severe damage found in the leaking hybrids studied was attributable to poor handling. Bent leads, broken glass, scratched gold plate, and the like all traced back to bad handling. Special carriers and handling fixtures reduced damage, but didn't always stop it. Figure 3 shows glass broken from lead bending on a 10^{-5} atm. cc/sec. leaking part. Ninety-five percent of the packages studied here showed evidence of poor handling in all of the nine categories.

Figure 3, glass broken from lead bending on a 10^{-5} atm. cc/sec. leaking part.

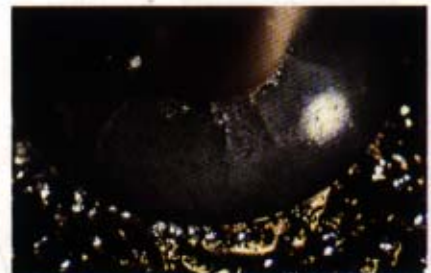
Radial cracks: Seventy-five percent of the leaking hybrids studied were found to have radial cracks. These cracks commonly are generated from the pins outward 20 to 60 percent of the distance to the outer diameter of the glass bead. In a few instances the radial cracks reached the outer diameter of the glass, usually when the pin was eccentrically located. Two causes were associated with these cracks. The first was from directly applied side loading of the pins, in many cases due to fixturing. The second cause was due to lead forming which caused side loads.

A very special case was found with the rectangular pins used in hybrids. The photomicrograph in figure 4 shows radial cracks from

Figure 4, radial cracks from severe side loading of a very heavy pin.

severe side loading of a very heavy pin. The leak was 5×10^{-6} atm. cc/sec.

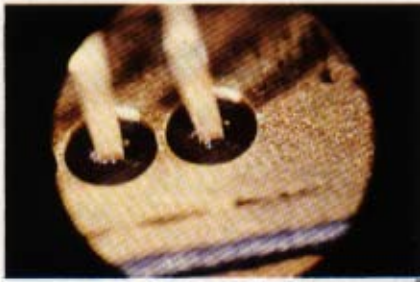
Figure 5, a hybrid with 5×10^{-7} atm. cc/sec. leak rate in a brown glass header.

Figure 5 demonstrates a hybrid with 5×10^{-7} atm. cc/sec. leak rate in a brown-glass header. The leaks here were caused by sharp cornered rectangular pins following solder or tin-dipping steps. This phenomenon often is difficult to accept due to dependence upon the metals and glass having been chosen with very similar differential thermal expansions.

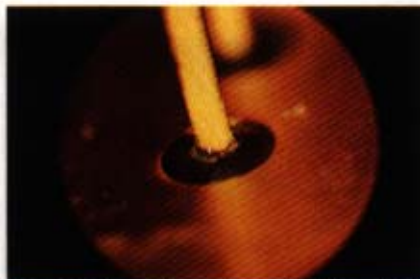
Figure 7, a circumferential break in the meniscus seal on 2×10^{-7} atm. cc/sec. leaking hybrid.

Meniscus chips: The meniscus seal is the bond of the pin to glass which has flowed, or wetted, up the pin to a very thin circumferential glass-metal bond. Headers typically are found to be very dependent upon the meniscus bond. Figure 7 shows a circumferential break in the meniscus seal on a 2×10^{-7} atm. cc/sec. leaking hybrid. A small amount of red dye exists by traveling through a leaking pin-glass joint. Figure 8 shows dye exiting through a thumbnail chip of a meniscus seal in a part with a 3×10^{-7} atm. cc/sec. leak rate.

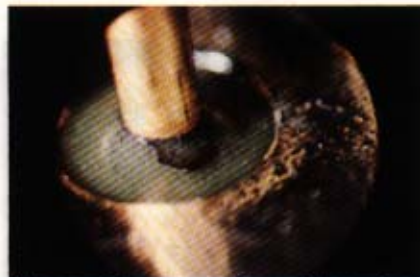
Figure 8, dye exiting through a thumbnail chip of a meniscus seal in a part with a 3×10^{-7} atm. cc/sec. leak rate.
