Hybrid Hermeticity And Failure Analysis

BY GEORGE R. NEFF, ISOVAC ENGINEERING INC., GLENDALE, CALIF.

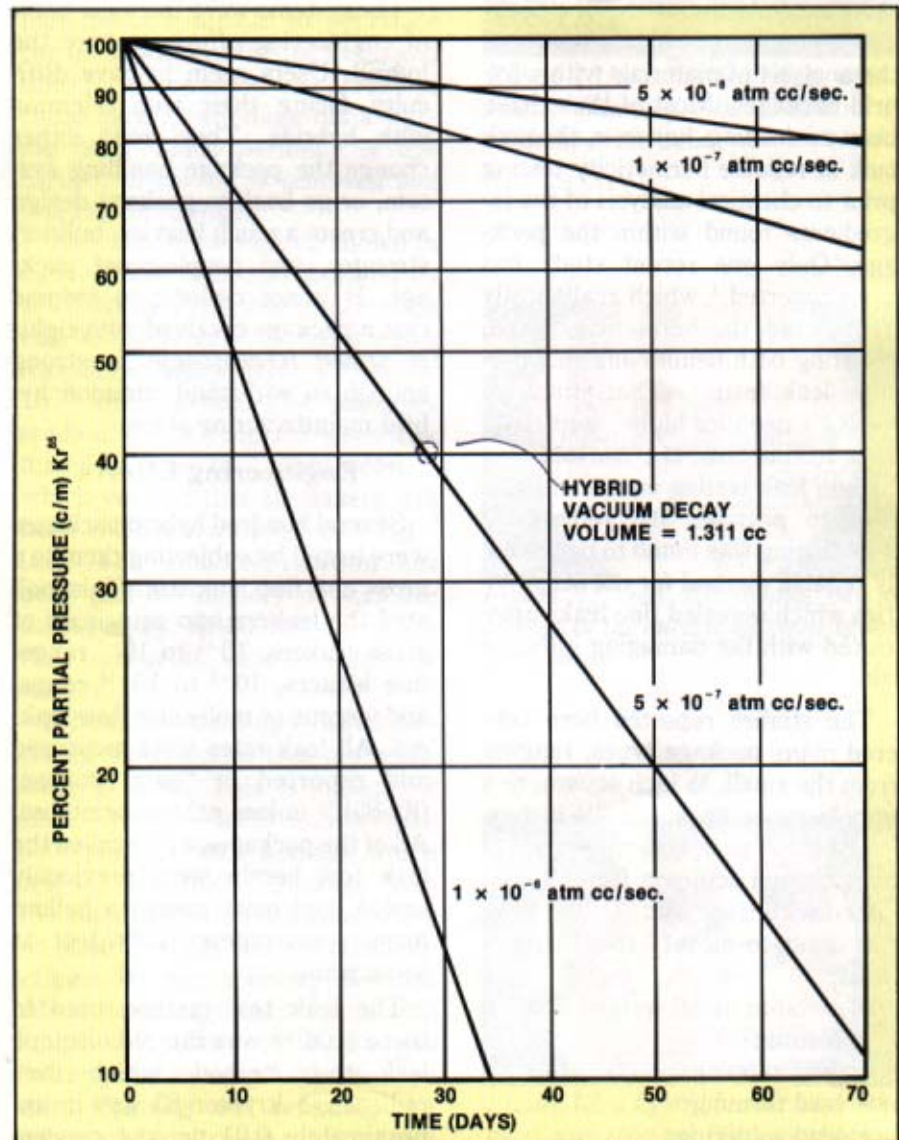
Figure 1, the typical decay of the partial pressure of Kr-85 within a part.

With this equation, the absolute leak rate is easily verified by measuring the change in partial pressure of Kr-85 within the part. A plot of a typical decay is seen in figure 1. The percent partial pressure reduction is synonymous with reduction in counts per minute. Thus, a 1.311 cc volume cavity hybrid with a 5×10^{-7} atm. cc/sec. (Kr-85) leak will lose 60 percent of its partial pressure in 28 days. It should be noted that this loss of Kr-85 through a molecular flow leak occurs when the package is standing in air. Conversely, air is leaking into the device in a similar manner.

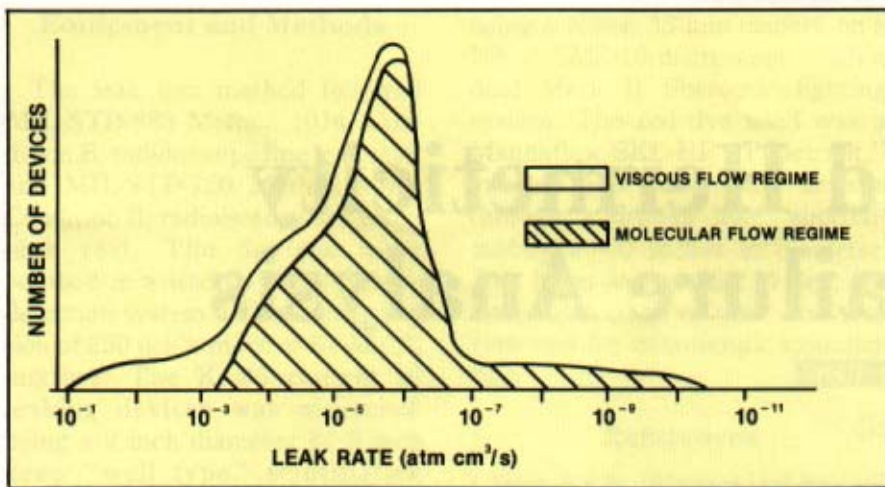
Figure 2, distribution of measured leak rates of all devices tested. Ten percent were for the range 10^{-3} to 10^{-4} atm. cm^3/s , 30 percent for 10^{-4} to 10^{-5} atm. cm^3/s , 50 percent for 10^{-5} to 10^{-6} atm. cm^3/s , 6 percent for 10^{-6} to 10^{-7} atm. cm^3/s , and 4 percent for $> 10^{-3}$ and $< 10^{-4}$ atm. cm^3/s .

The bell distribution curve in figure 2 represents data from several million hermetic packages which were leak tested quantitatively, measured to establish molecular or viscous flow, and ultimately tested, in many cases, to a sensitivity of 1×10^{-10} atm. cc/sec. (Kr-85). One dominant factor was established through this study. Most of the leaking devices were found to have a molecular flow type of porosity leakage. Many of the leakers were found to be molecular-flow leakers, with total or cumulative leakage equal to a gross leak. This often is found to produce confusion when a leak rate of 5×10^{-5} does not produce bubbles by conventional bubble test methods. It should be realized that such a leak often is made up of perhaps 500 1×10^{-7} atm. cc/sec. porosity leaks, with each pore requiring infinite time to produce a visible bubble.
